Tankshal Pol Masjid

CEPT Conservation Site School

An initiative by Center for Heritage Conservation (CHC), CRDF supported by Ahmedabad Sunni Muslim Waqf Committee and funded by donations. This report summarises the site school activities from January '22 to September '23. We thank all the donors and contributors for supporting this initiative.

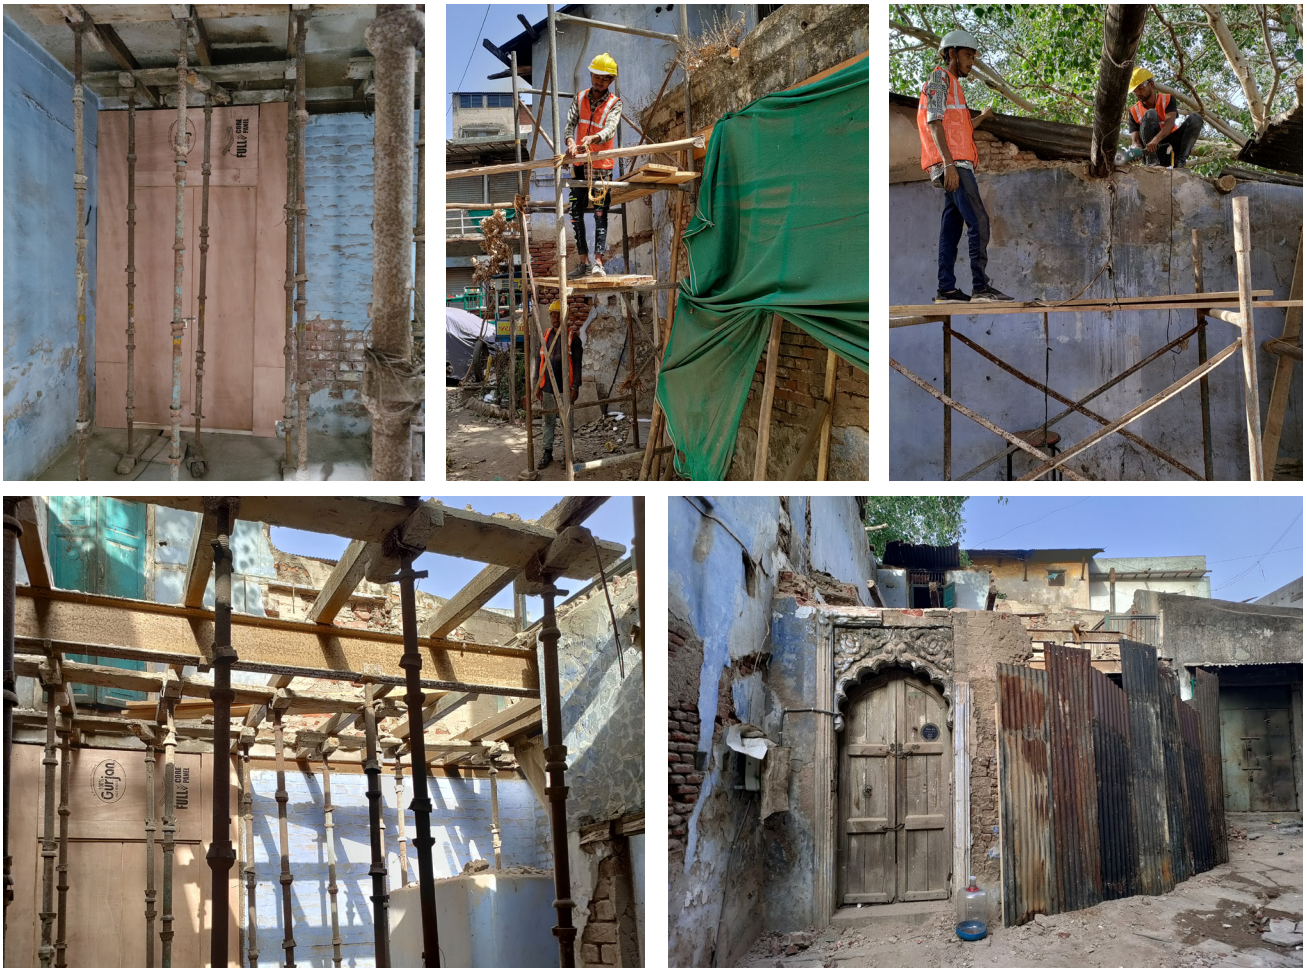
Steps in safeguarding and careful dismantling of the entry structure (photographs by Zeus Pithawalla)

Undertaken in May 2022, the activity involved dismantling the entrance wall of the Mosque, located on the South-west portion of the site. The local municipal body had issued a notice regarding the unsafe condition of this wall as it was out of plumb and posed a threat to the neighboring residents. This entrance wall is part of an extension to the site and not within the core structure.

The initial steps of dismantling were to carefully remove the roofing sheets, partially unhinged timber door and window frames, sensitively cut the timber logs/beam, dismantle the unloaded first-floor wall, and carefully remove the flooring (cement layer on an earlier brick and lime composite) while retaining the I-sections and timber purlins frame. The ground floor wall was then dismantled brick by brick; the challenge was to retain the structure's entrance door archway with intricate stucco work. All materials retrieved during dismantling stand as a record of the earlier construction and have been cataloged and stored methodically for archiving purposes and to reuse for later stages of repair/rebuilding.

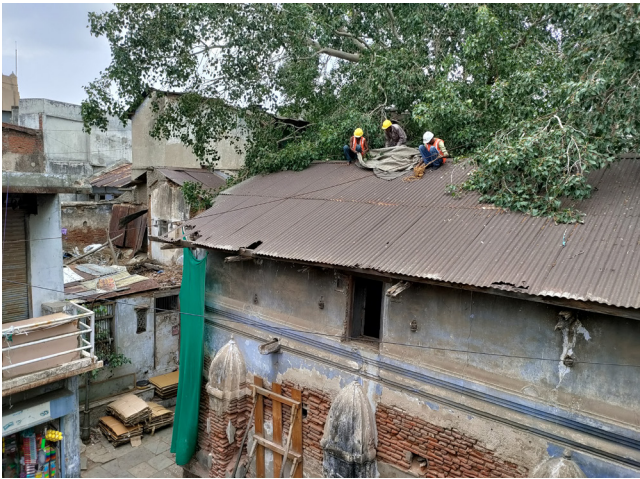
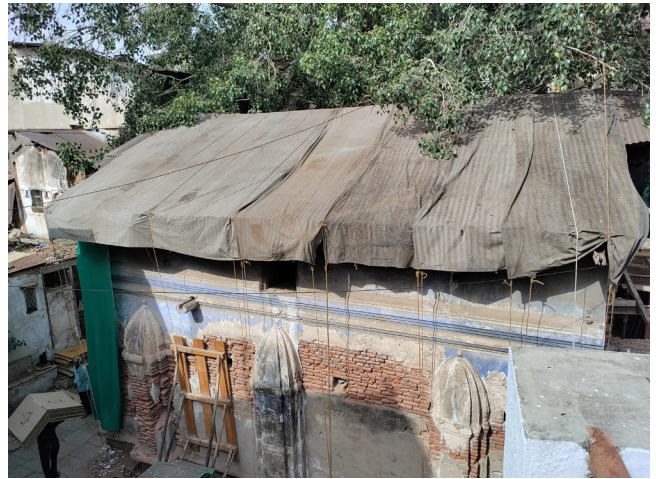
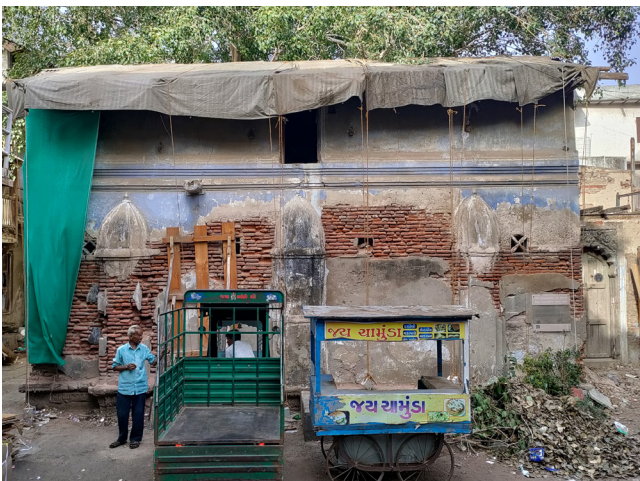
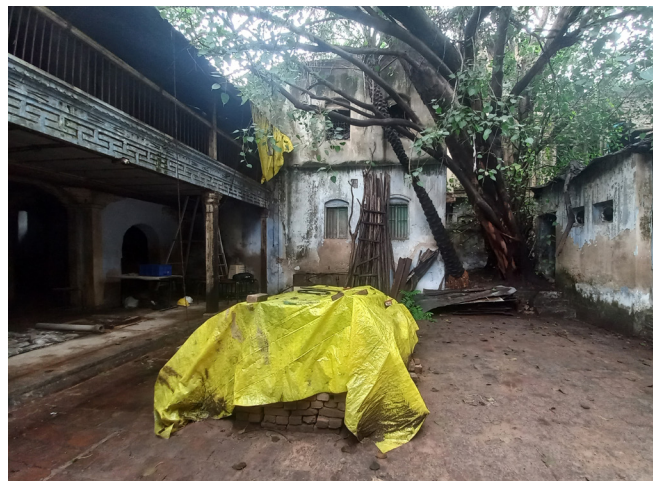
In preparation for the monsoon in June 2022, the roof of the Jammata Khana was covered with Tarpaulin/Canvas sheets to prevent water seepage. The roofing sheets had been damaged, resulting in water ingress and dampness, especially along the walls. In the case of the Imam’s room and the store room, the roof had deteriorated beyond repair; it was carefully removed and temporarily covered with canvas sheets supported on the timber frame. The northwest corner of the structure, identified as a weak point, was covered from the roof to the ground to prevent further exposure. All the furniture was moved indoors, and the dismantled materials stored on site were also covered with tarpaulin sheets to prevent rain damage. Regular checkup of the precautionary measures was done over the period of monsoon to ensure its efficient functioning.

Covering the roof and north west corner of Jammata Khana in preparation for monsoon (photographs by Zeus Pithawalla)

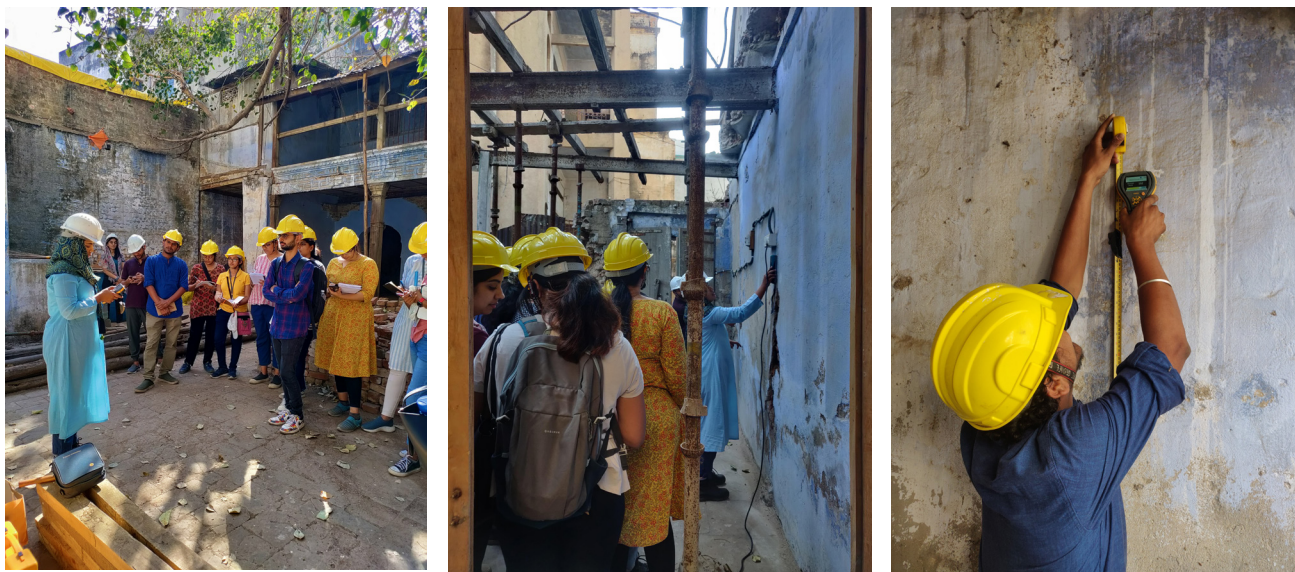
As a part of the structural conservation course offered to the students of second-semester masters in Conservation and Regeneration program (MCR at Faculty of Architecture CEPT University), a two-day workshop was organized on 20th & 22nd February 2023 to understand the different non and minor destructive testing methods available to aid structural conservation. The workshop was conducted by Nigar Shaikh (Conservation Engineer and Course Tutor) and supported by Zeus Pithawalla (Conservation Architect, Site-In charge for Tankshal Pol Masjid). This workshop introduced students to the theory and different techniques used for Non-destructive and Minor-destructive testing and gave them hands-on experience to engage with the equipment of UPV, Rebound Hammer, Borescope, and Moisture meter.

Non and minor destructive testing being conducted on Tanshal Pol Masjid (photographs by Komal Gandhi)

The workshop was aimed to create an understanding of the different non-invasive testing methods and how the combination of these tests helps investigators gain a comprehensive understanding of a building's condition without causing damage to the historic fabric. These methods are vital for preserving the maximum historic fabric while providing relevant information regarding the building material and structure. The recommendations made based on the tests will help preserve the historic building's structural integrity and historic fabric for future generations.
